**NASA-UVA LIGHT AEROSPACE ALLOY
AND STRUCTURES TECHNOLOGY PROGRAM**

**Supplement: RESEARCH ON MATERIALS FOR THE
HIGH SPEED CIVIL TRANSPORT**

SEAS Report No. UVA/528266/MSE97/124
July 1997

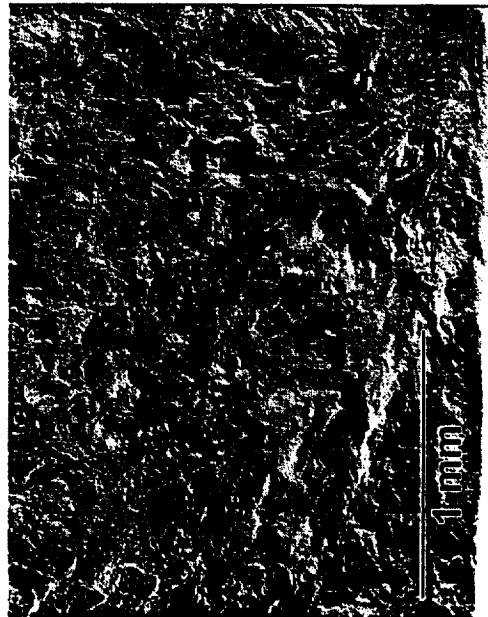
Fatigue Initiation Site, SA Ti 15-3

R = 0.1, frequency = 15 Hz, Specimen IF2

SEM view of fracture surface, specimen IF2. Initiation occurred in lower right corner. (a) low magnification, (b) high magnification. Both views show that fatigue crack propagation is transgranular with a crystallographic dependence. The crack changes plane between grains, but is not confined to grain boundaries.

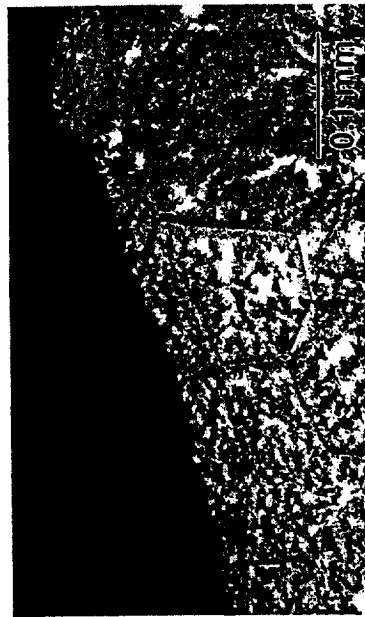
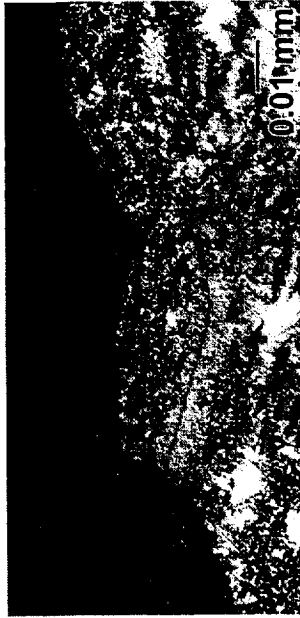
Fatigue Crack Path, Cross-Section

Cross section of fracture surface near (not at) initiation site, specimen IF2, (a) low magnification, (b) high magnification.

14. Fatigue crack surface topography.
15. Fatigue crack path, cross-section showing crystallographic dependence of crack propagation.
16. Duplex aged microstructure.

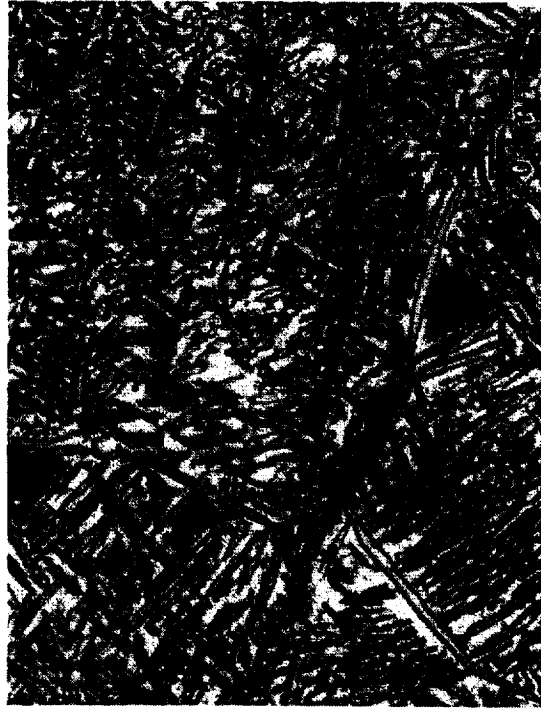
Duplex Aging

High T/ Low T aging is expected to produce a bimodal structure of coarse and fine alpha in the beta matrix.

SDA microstructures, solution treated, 800°C, 1 hr then duplex aged, 600°C, 20 hrs followed by 400°C, 75 hrs, l-t orientation, (a) low magnification, (b) high magnification.

Duplex aged (SDA) tensile and fatigue specimens were solution treated at 800°C for 1 hr, quenched, then aged at 600°C for 20 hr, quenched, and aged again at 400°C for 75 hr. This produced a uniform distribution of acicular α phase within the β grains as well as a high volume of continuous α at the grain boundaries. Combined with low tensile results, this unexpected microstructure indicates some deviation in the heat treatment procedure from that reported in the literature. The 20 hour exposure at 600°C appears to be far too long to optimize properties.

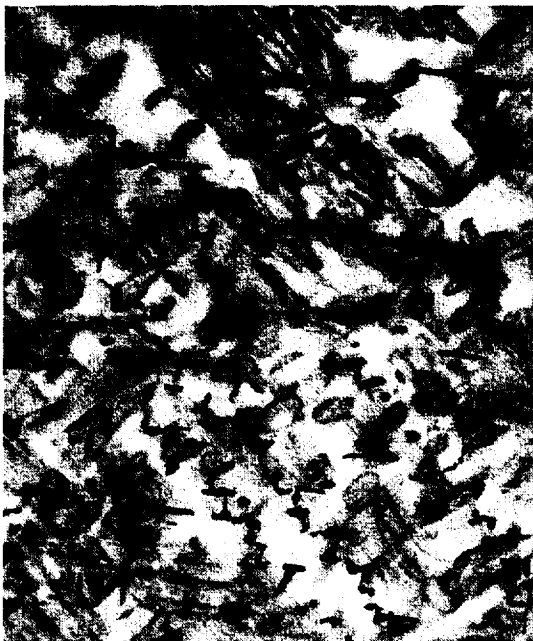
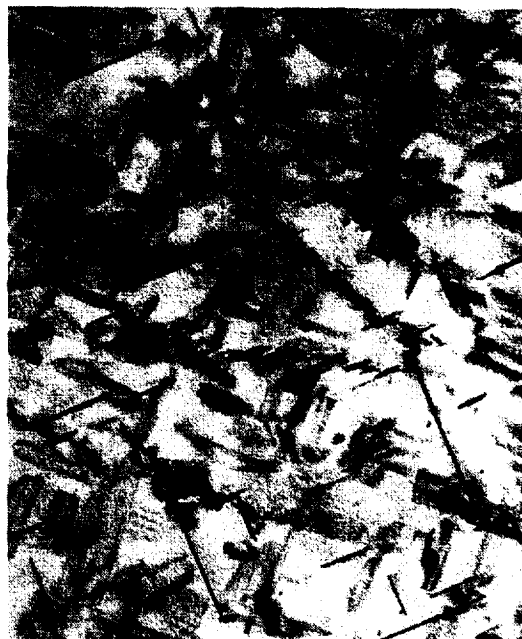
**Bright-field electron micrographs of alloy C415 and C416
in the crept condition of 275°F-30ksi-1681h.
The electron beam is approximately parallel to a <001> zone axis.**

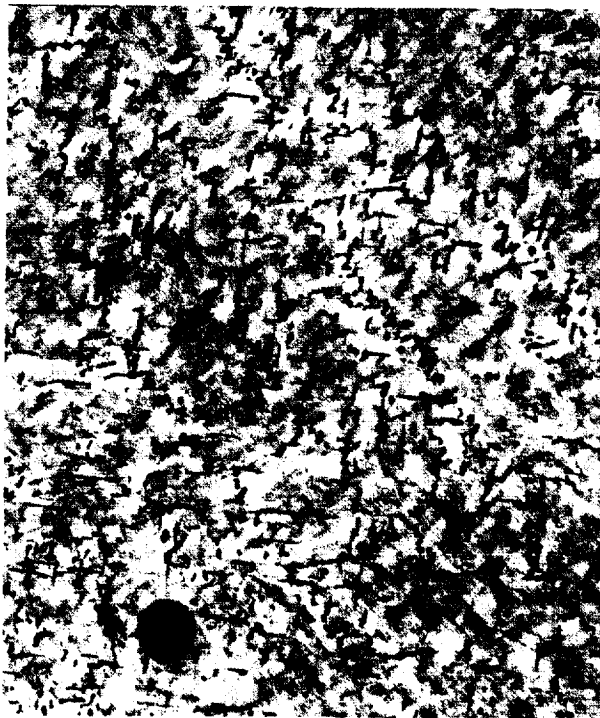
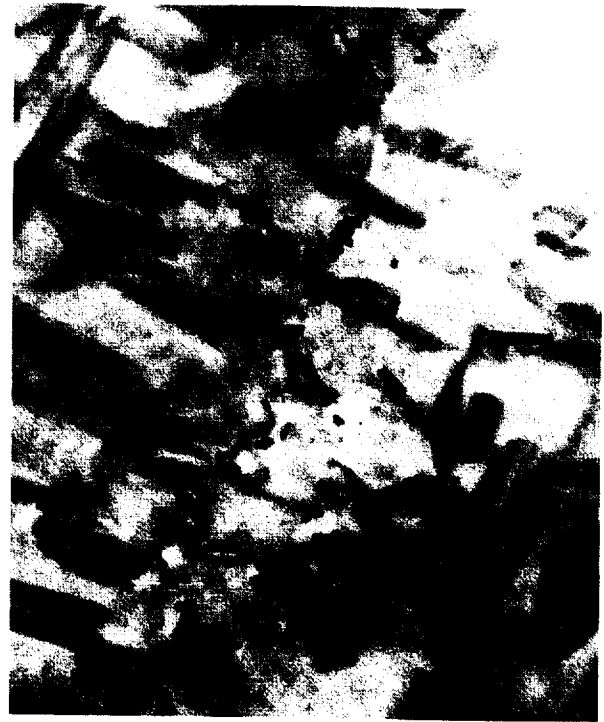
Transmission electron micrographs from C415 crept 1681h at 275°F-30ksi, showing S' precipitates on dislocations.

Creep behavior of candidate alloys reflects microstructural and compositional influence, being enhanced by the presence of the Ω phase and deteriorating with precipitation of the S' phase at grain boundaries and dislocations within the Al-Cu-Mg-Ag system. Creep exposure and elevated temperature microhardness testing of all alloys are continuing in order to provide valuable time-temperature-transformation (TTT) data

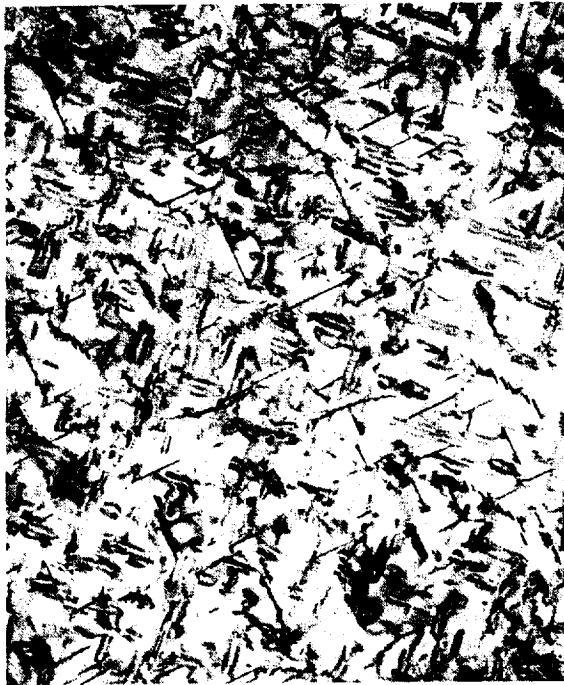
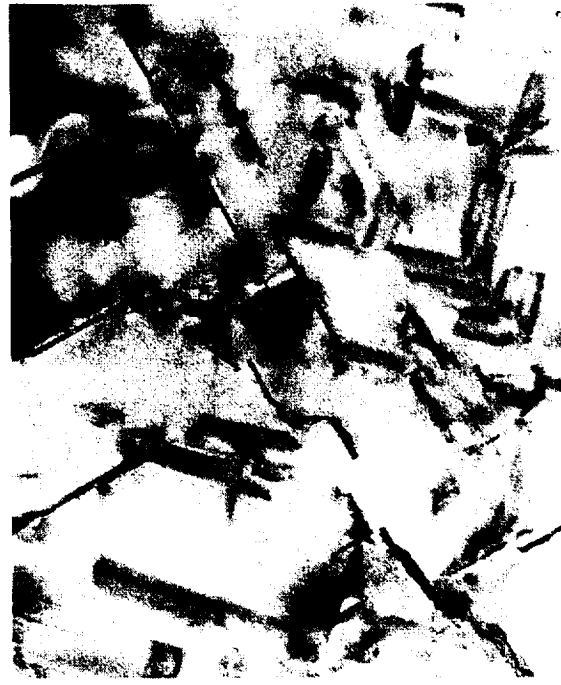
Transmission electron micrographs from C416 crept 1681h at 275°F-30ksi, showing theta prime precipitates on dislocations.

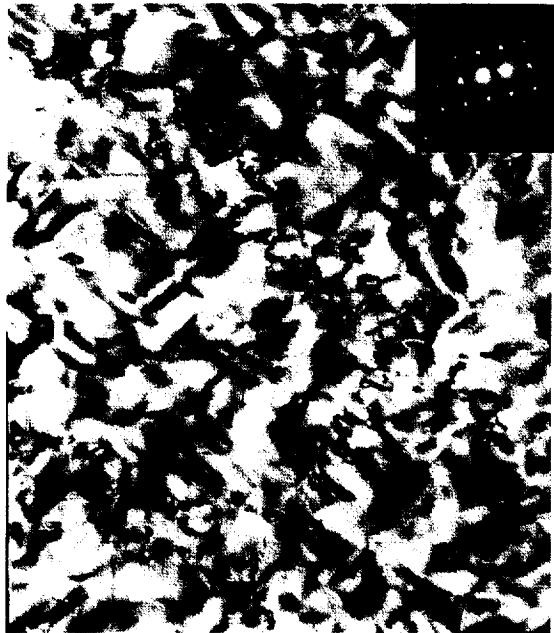
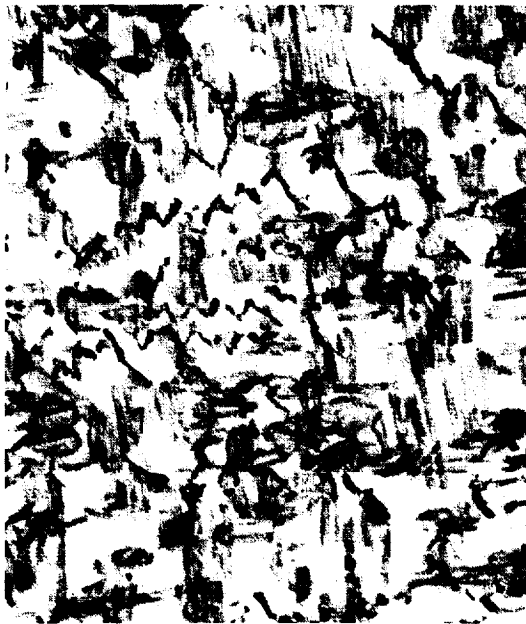
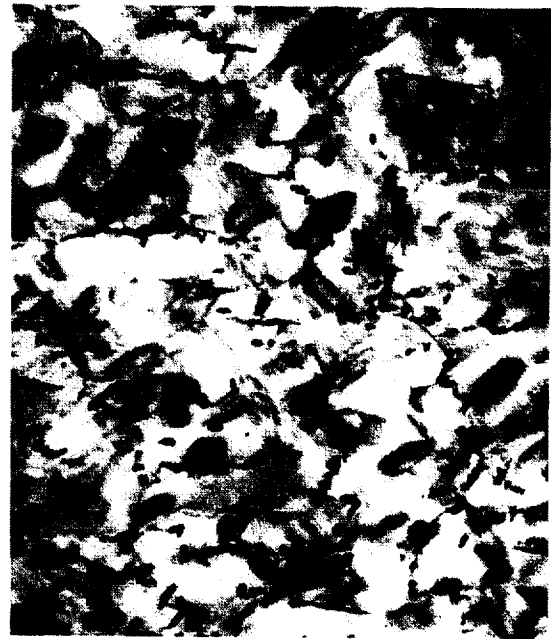
a.
the operating reflection is $\{200\}$

Bright-field electron micrographs of C415 in the crept condition of :
a), b) 275°F-20ksi-1341h; c) 275°F-30ksi-1681h.
The electron beam is approximately parallel to $\langle 001 \rangle$.

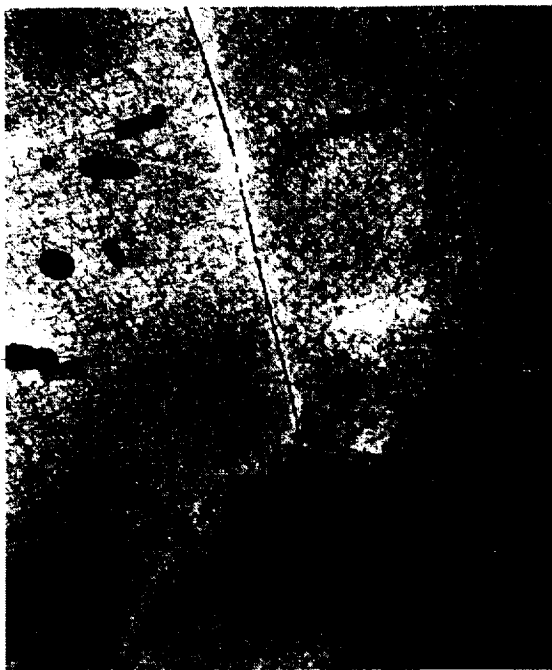
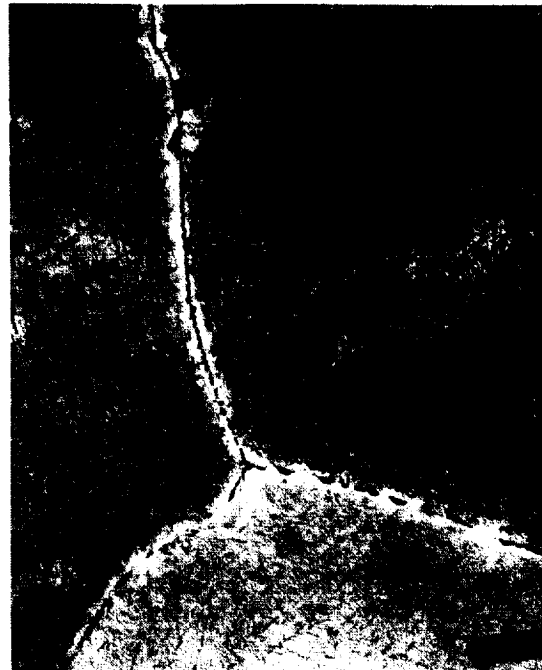
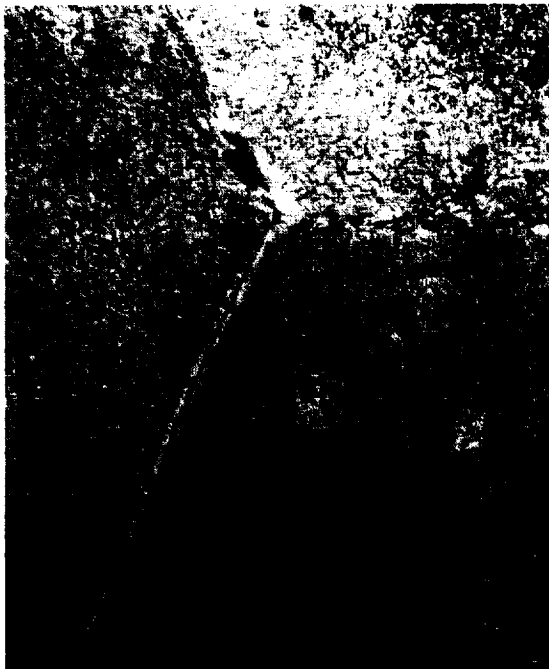
**Transmission electron micrographs of alloy C415,
showing the precipitates within the grain boundary region.
a) prior to cree; b) thermal exposed 3000 hours at 275°F;
c) crept 275°F-20ksi-1341h; d) crept 275°F-30ksi-1681h.**

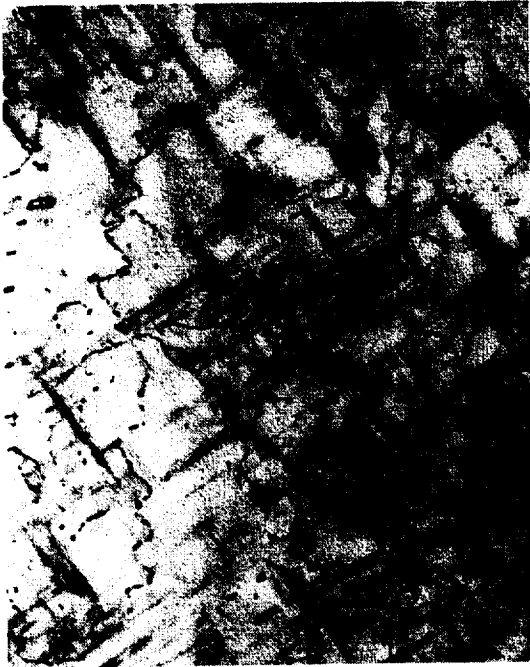
**Bright-field electron micrographs from alloy CM.001
prior to creep.
The electron beam is approximately parallel to <001>.**
